**RE: Phase II Environmental Site Assessment  
Former Lynchburg Foundry Warehouse Site  
1800 Garnet Street, Lynchburg, Virginia  
Draper Aden Associates Project No. 2109460**

# Geophysical Study at 1800 Garnet Street Lynchburg, Virginia

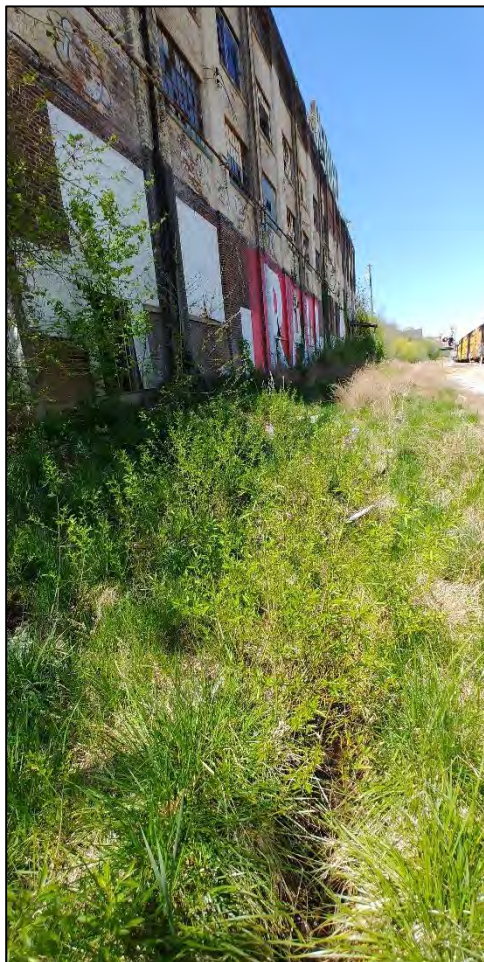
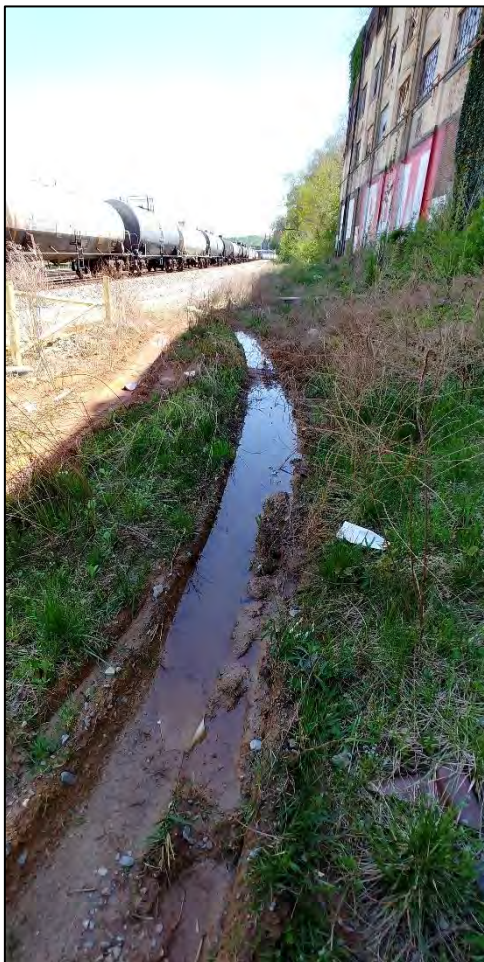
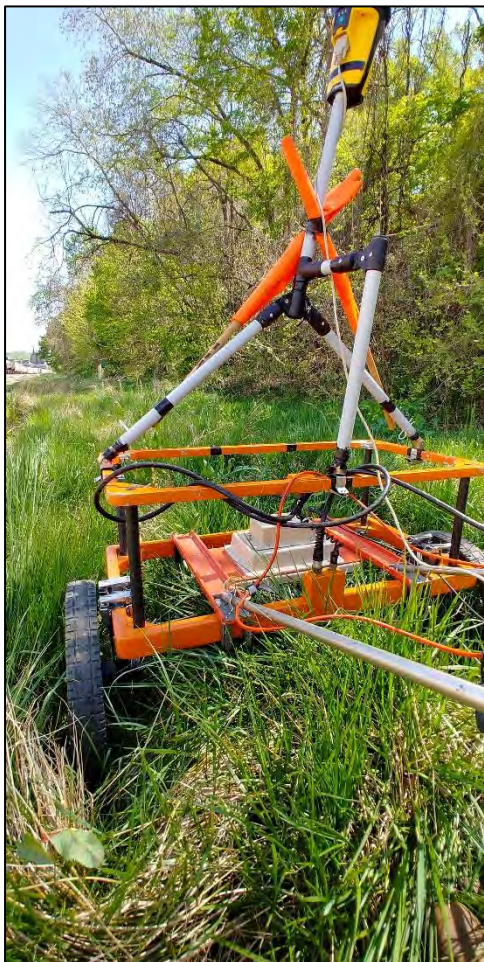
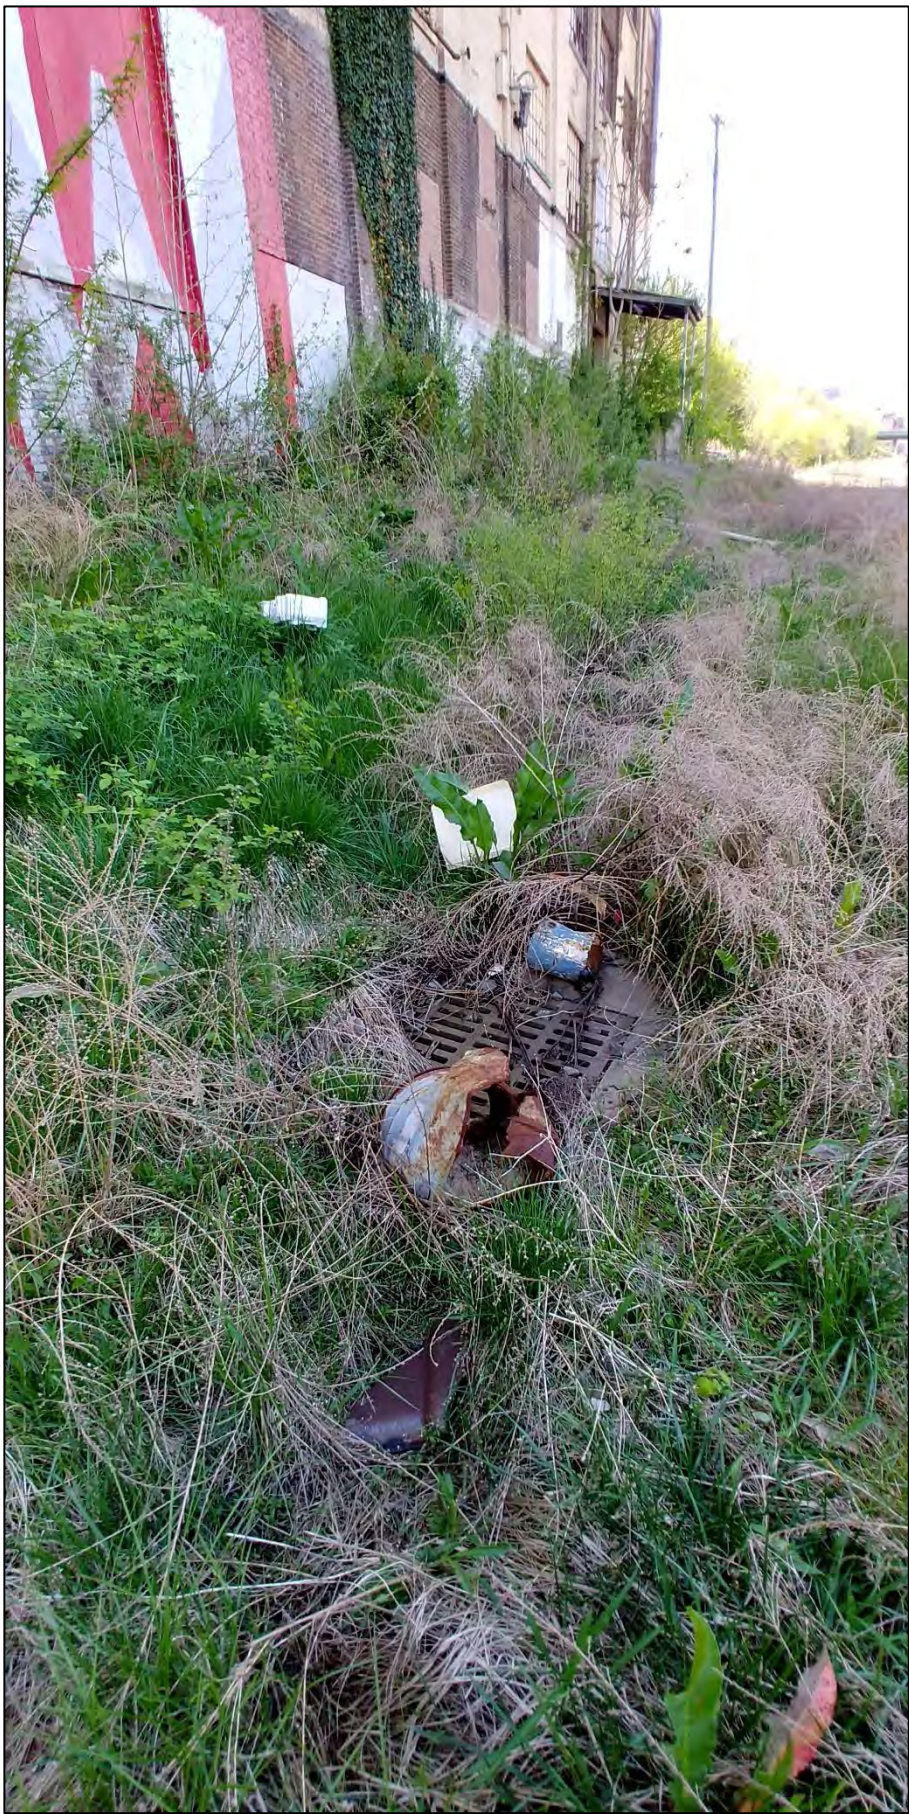
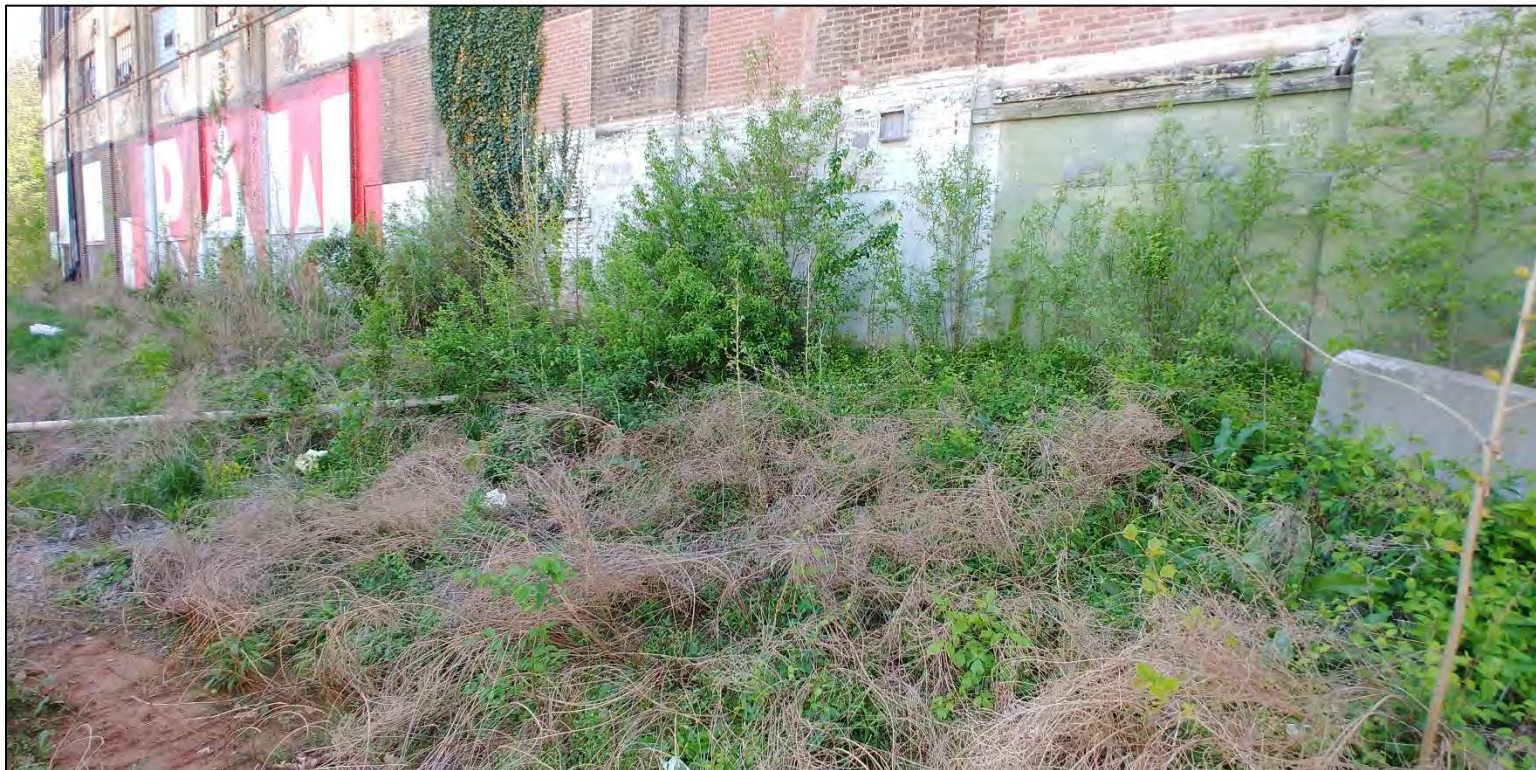
FIGURE  
2

Looking Northwest

Looking Southeast

Looking South

To meet the objectives of the study, we had proposed to utilize a combination of ground penetrating radar (GPR) and time-domain electromagnetics (TDEM, also called EM-61). However, the ground conditions at the site were not conducive to GPR data collection, due to thick, tall vegetation and deep, water-filled ruts extending in the long direction of the study area, and therefore only EM-61 methods were utilized. Photographs depicting the site conditions are illustrated in Figure 2.

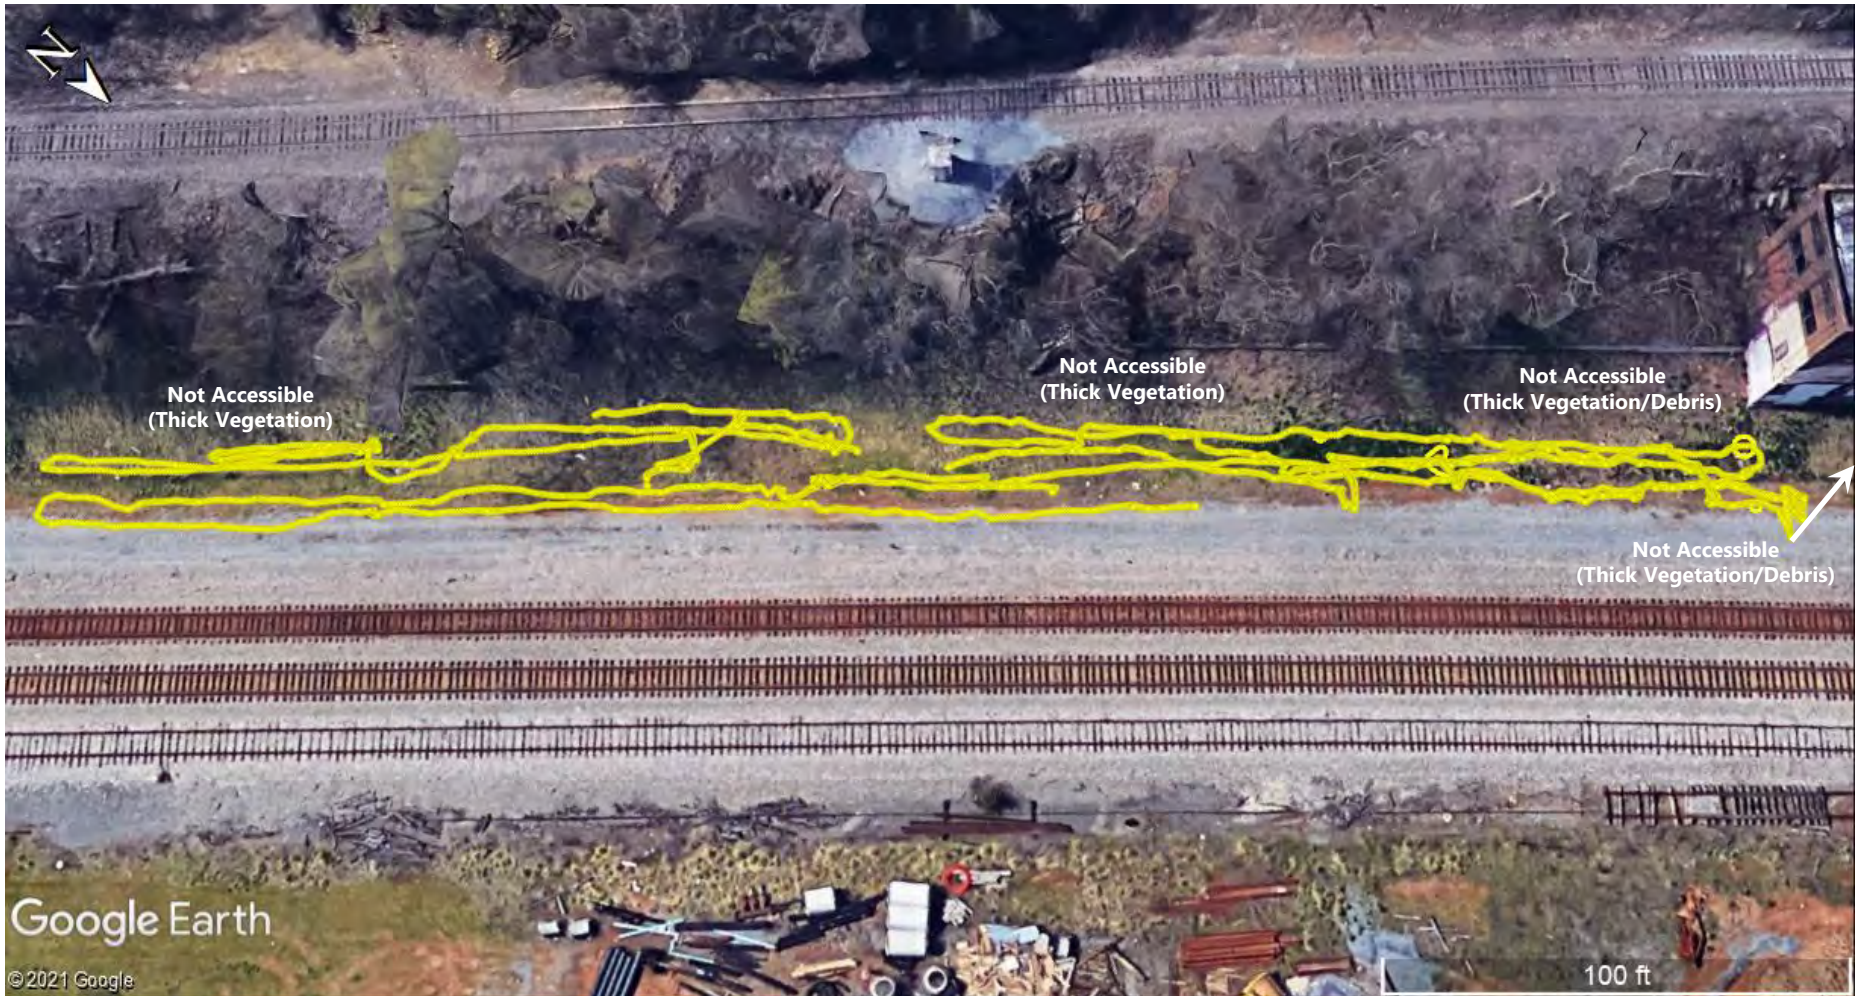
## GPS Track of EM61 Data Collection

accuracy. Figure 3 depicts the distribution of the EM61 traverses, which were predominantly in the long direction of the study area (northwest-southeast). The orientation of the traverses was largely dictated by the presence of deep, water-filled ruts extending in the long direction of the study area. These deep ruts, combined with dense, tall vegetation, made it not feasible to conduct traverses in the short direction of the study area (northeast-southwest). Additionally, the ground conditions between the building and the railroad right-of-way made it not feasible to collect EM data along the east side of the building. These prohibitive conditions included thick vegetation, muddy, water-filled deep ruts, and an abundance of large window pane fragments and metallic debris, the latter of which would have generated numerous EM anomalies in the data set.

Based on site conditions, it was only feasible to conduct traverses with the EM61 in the long direction of the study area (northwest-southeast), due to the presence of deep, water-filled ruts extending in the long direction of the study area. These deep ruts, combined with dense, tall vegetation, made it not feasible to conduct traverses in the short direction of the study area (northeast-southwest). Additionally, the ground conditions between the building and the railroad right-of-way made it not feasible to collect EM data along the east side of the building. These prohibitive conditions included thick vegetation, muddy, water-filled deep ruts, and an abundance of large window pane fragments and metallic debris, the latter of which would have generated numerous EM anomalies in the data set.

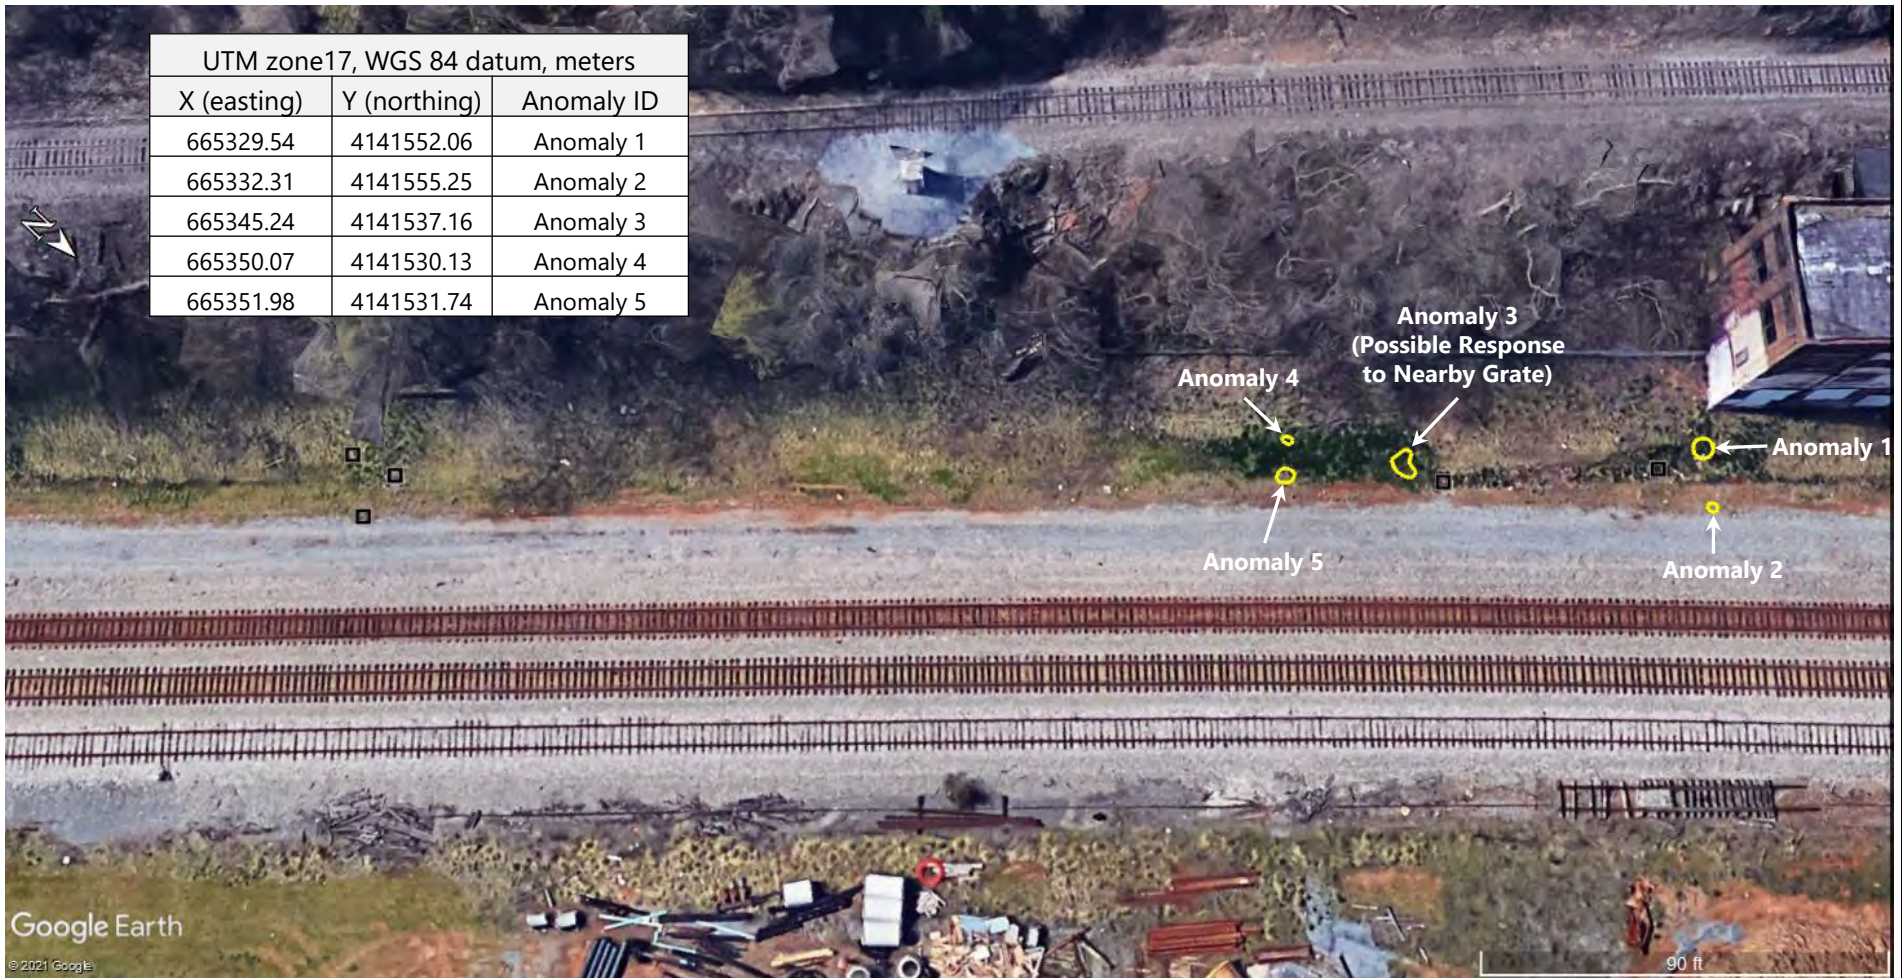
## Locations of EM61 Anomalies on Aerial Imagery

The results from the EM61 data analysis revealed five anomalies to the east of the building which were not directly correlated to metallic objects or structures observed at the ground surface, identified Anomalies 1 through 5. The locations of Anomalies 1 through 5 are depicted on Google Earth aerial imagery in Figure 5. The coordinates of Anomalies 1 through 5 are provided in the table in Figures 4 and 5, in the following coordinate system: UTM zone 17, WGS84 datum, meters.
